EUROPEAN VISUAL INSPECTION CATALOGUE (EVIC) FOR FREIGHT WAGON AXLES

to be applied in light maintenance of freight wagons in workshops

Joint Sector Group for ERA Task Force on wagon/axle maintenance

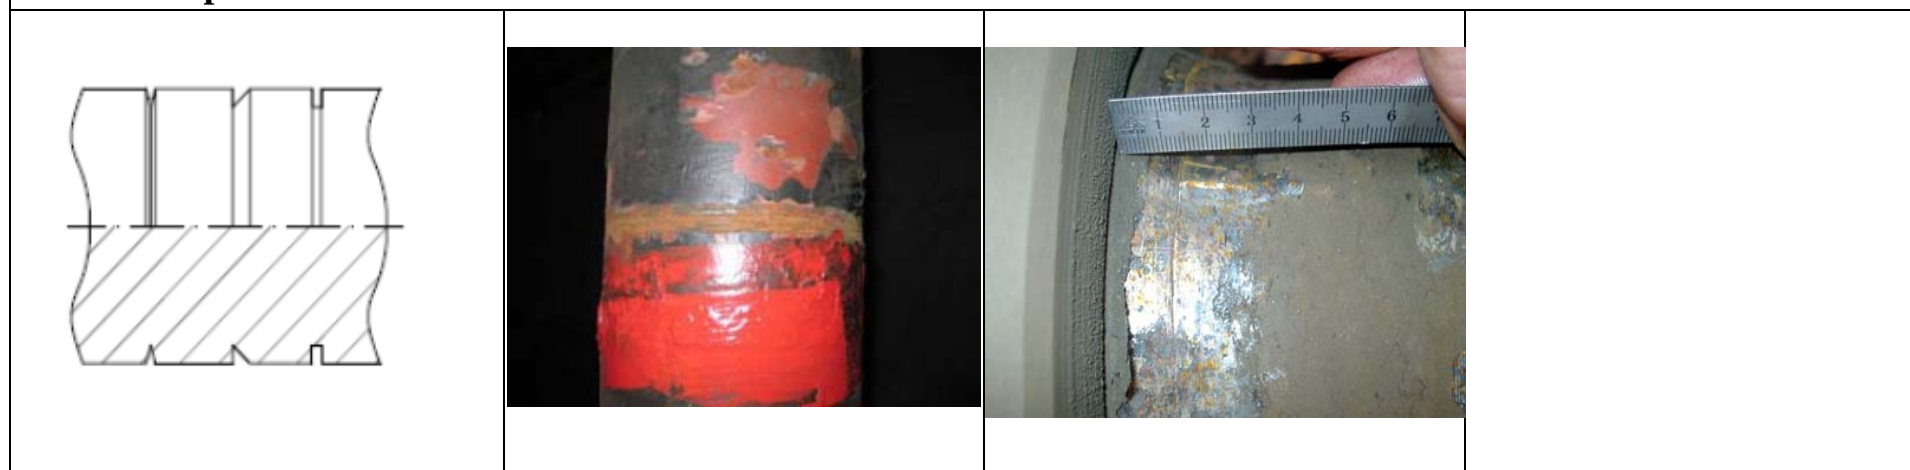
| 31 Mechanical damage – sharp edged circumferential fluting | | Painted axles |

| | Flutes are characterised by sharp edged circumferential sharp-edged transitions. | |
| | Mechanical damage to the base material in the form of fluting is inadmissible. | |

| | Check on the wagon why this damage could have occurred and repair accordingly | |
| | Remove from service according | Case A |

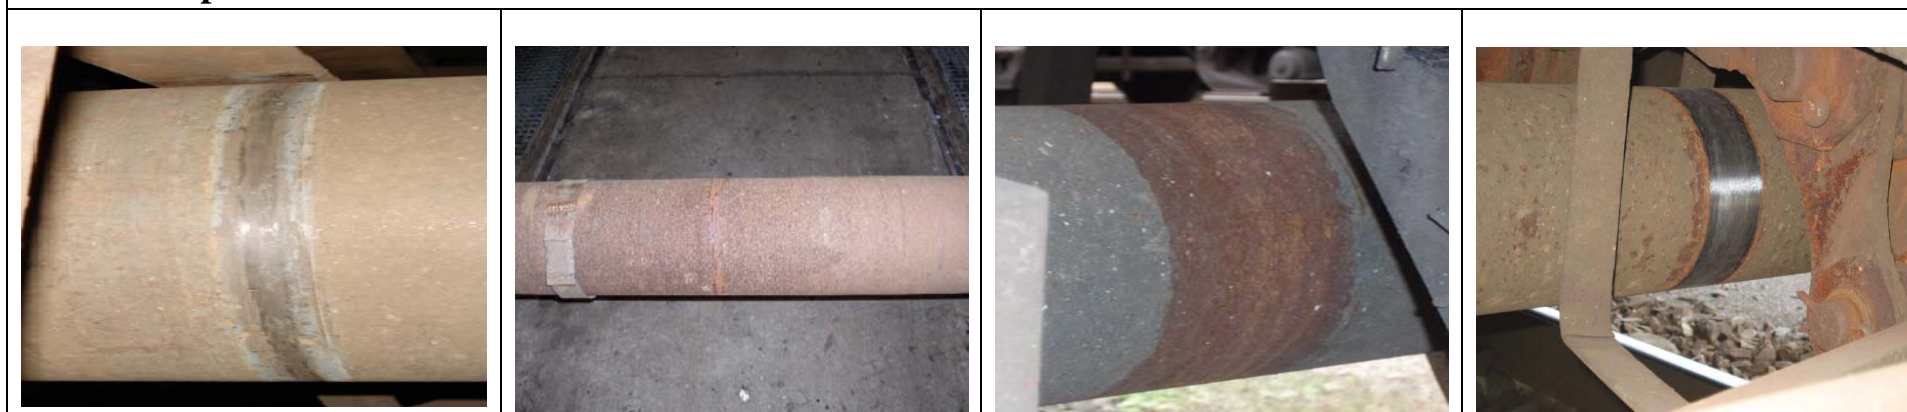
| 32 Mechanical damage – smooth edged circumferential grooves | | Painted axles |

| 32 Mechanical damage – smooth edged circumferential grooves | | Painted axles |
|---|--|---|
| | Characterised by smooth transitions in the edges (GCU Annex 9, 1.6.2). Pitting that arises during operation (caused e.g. by brake lever connectors dragging) involves damaged anti-corrosion coating | |

| 32 Mechanical damage – smooth edged circumferential grooves | | Painted axles |
|---|--|---|
| | Check on the wagon why this damage could have occurred and repair accordingly | |
| | Remove from service | Case B |
| | if there is damage to the base material > 1mm: (acc. GCU) | Case A |

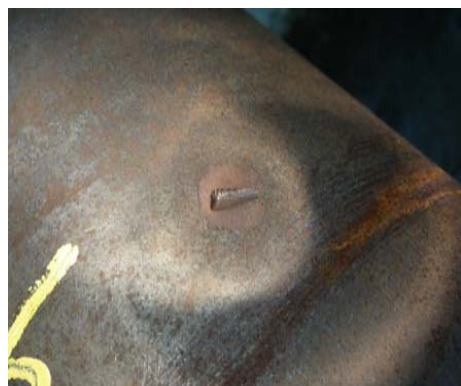
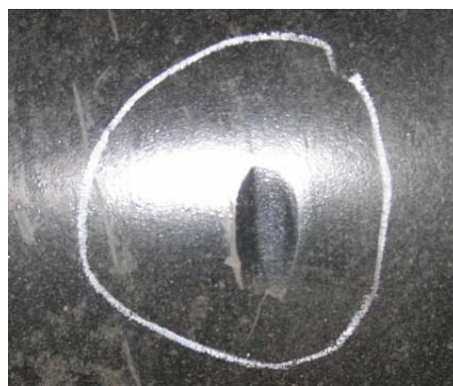
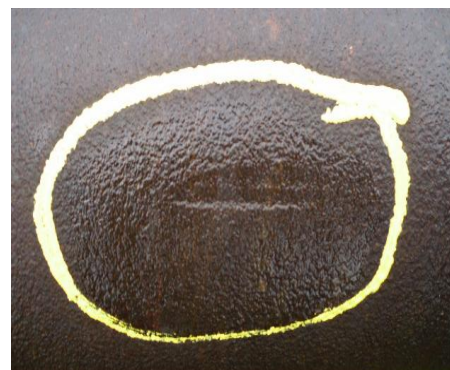
| 33 Mechanical damage – sharp edged notching | | Painted axles |

| 33 Mechanical damage – sharp edged notching | | Painted axles |
|---|---|---|
| | Sharp edged notches occur locally and are characterised by sharp-edged transitions. | |
| | Mechanical damage to the base material in the form of notching is inadmissible. | |

| 33 Mechanical damage – sharp edged notching | | Painted axles |
|---|---|---|
| | Remove from service (according to GCU criteria) | Case A |

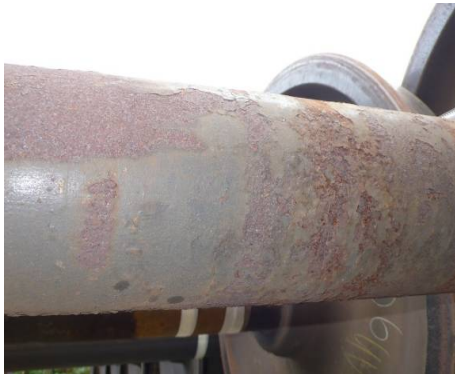
| 35 Surface damage – large and heavily corroded areas | | Painted axles |

| 35 Surface damage – large and heavily corroded areas | | Painted axles |
|--|---|---|
| | Surface damage to base material in form of large and heavily corroded areas (old corrosion protection) is inadmissible. | |

| 35 Surface damage – large and heavily corroded areas | | Painted axles |
|--|---|---|
| | Remove from service | Case B |

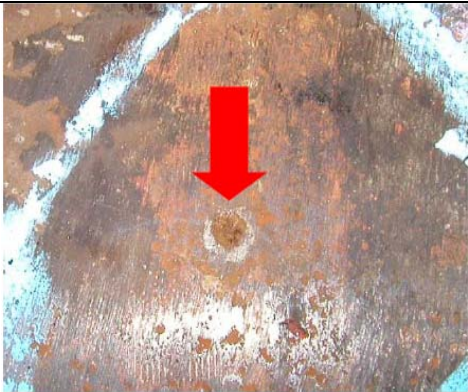
| 36 Surface damage – single, deeply pitted corrosion scars | | Painted axles |

| 36 Surface damage – single, deeply pitted corrosion scars | | Painted axles |
|---|--|---|
| | Surface damage to the base material in the form of marked, local corrosion scars (resulting e.g. from chemical effects) is inadmissible. | |

| 36 Surface damage – single, deeply pitted corrosion scars | | Painted axles |
|---|--|---|
| | Remove from service | Case B |

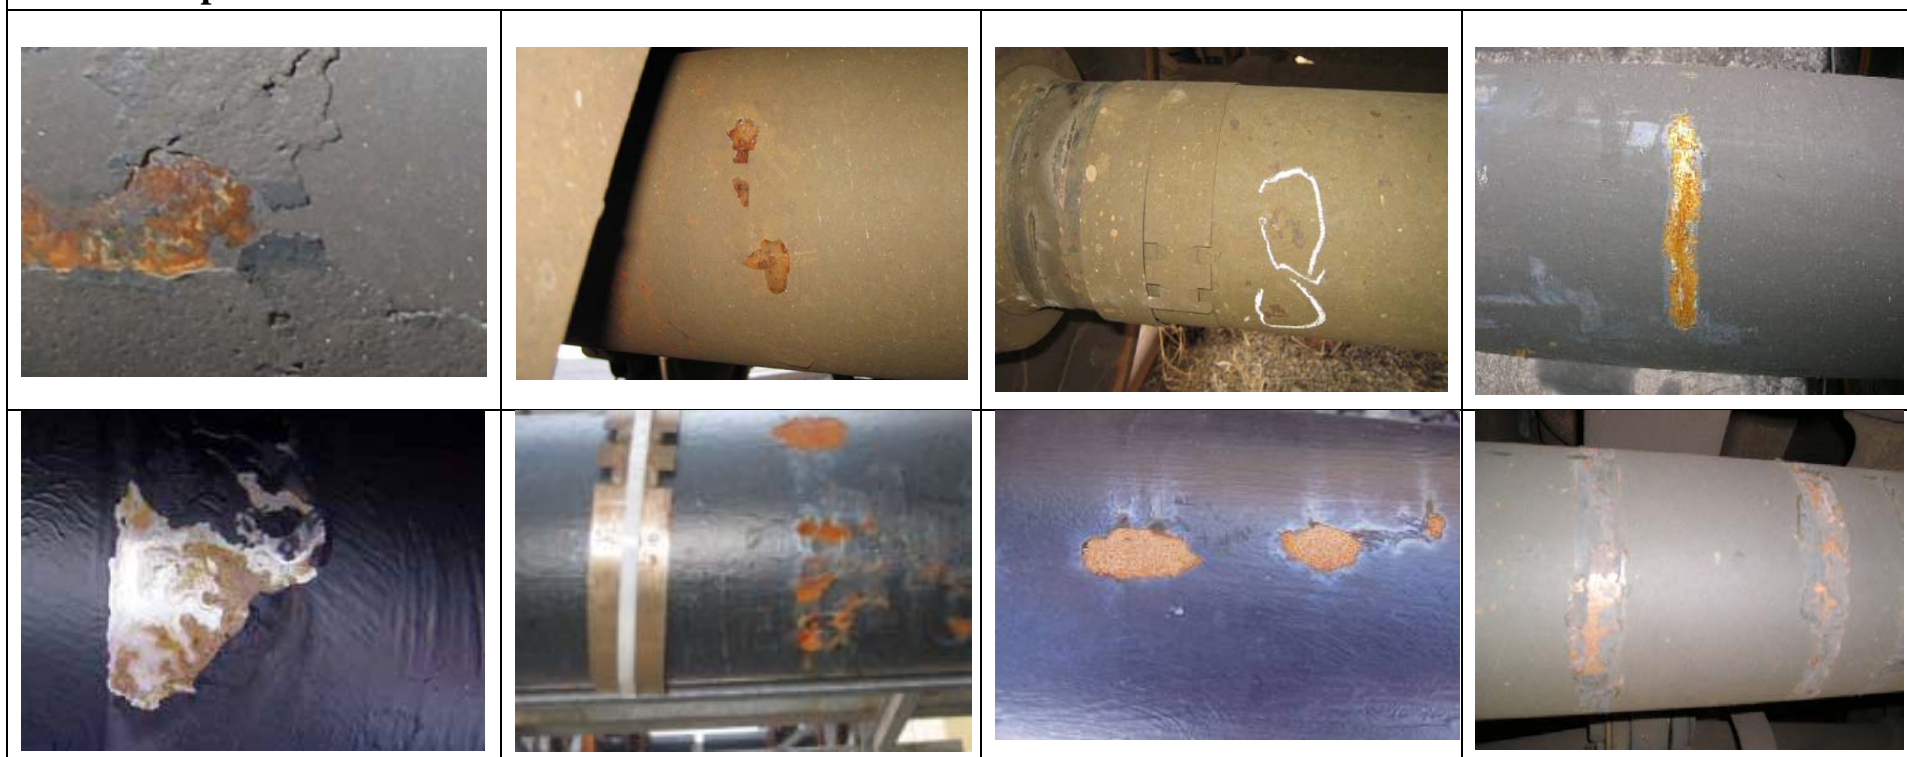
| 37 Coating damage – with or without corrosion | | Painted axles |

| 37 Coating damage – with or without corrosion | | Painted axles |
|---|--|---|
| | Minor lack of an anti-corrosion coating, whether corrosion is involved or not. | |

| 37 Coating damage – with or without corrosion | | Painted axles |
|---|--|---|
| | Leave in service acc. case C and/or repair the damage in situ on the wheelset | Case C |

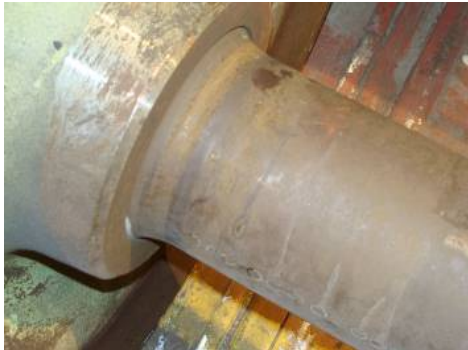
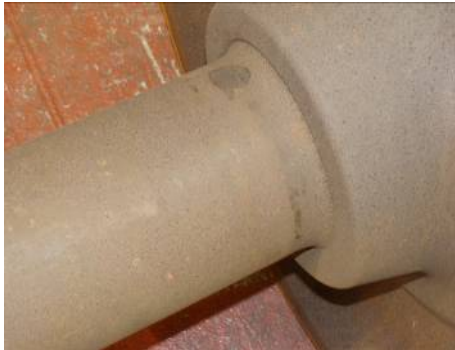
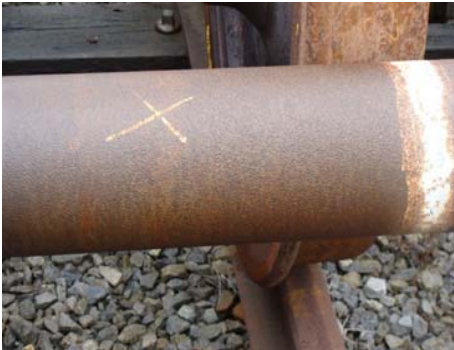
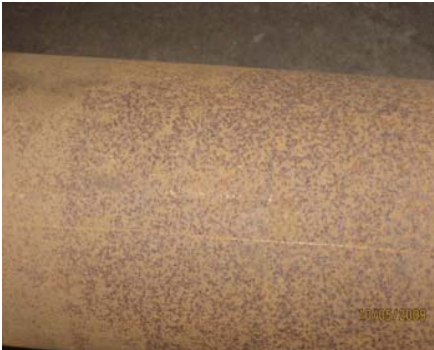
| 40 No defect - admissible surface appearance | | Unpainted axles |

| 40 No defect - admissible surface appearance | | Unpainted axles |
|--|--|---|
| | There exist maintenance rules that do not require any anti-corrosion protection. Axles and wheels stay unpainted in such cases and show a thin and uniform layer of rust on their surfaces in service. | |
| | Deep corrosion is not accepted. | |

| 40 No defect - admissible surface appearance | | Unpainted axles |
|--|--|---|
| | Leave in service wheelset “as new”, “very good”, “good” and “acceptable” | |

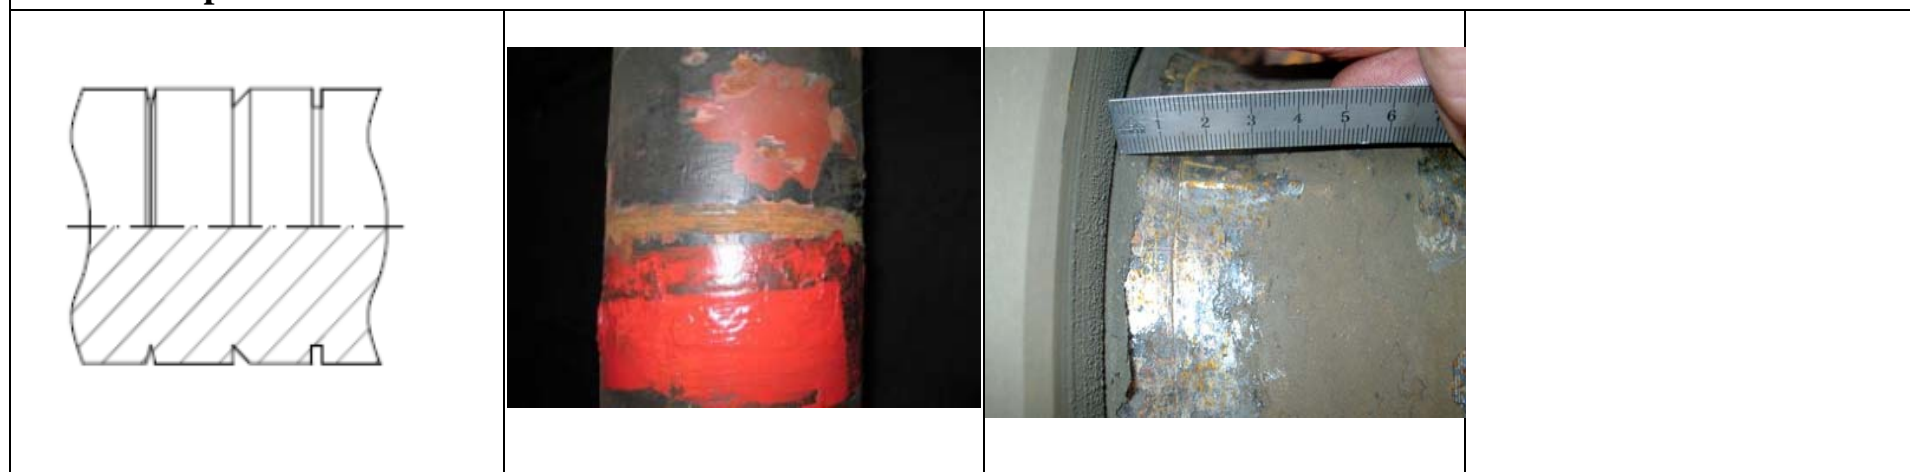
| 41 Mechanical damage – sharp edged circumferential fluting | | Unpainted axles |

| 41 Mechanical damage – sharp edged circumferential fluting | | Unpainted axles |
|--|--|---|
| | Flutes are characterised by sharp edged circumferential sharp-edged transitions. | |
| | Mechanical damage to the base material in the form of fluting is inadmissible. | |

| 41 Mechanical damage – sharp edged circumferential fluting | | Unpainted axles |
|--|--|---|
| | Check on the wagon why this damage could have occurred and repair accordingly | |
| | Remove from service according | Case A |

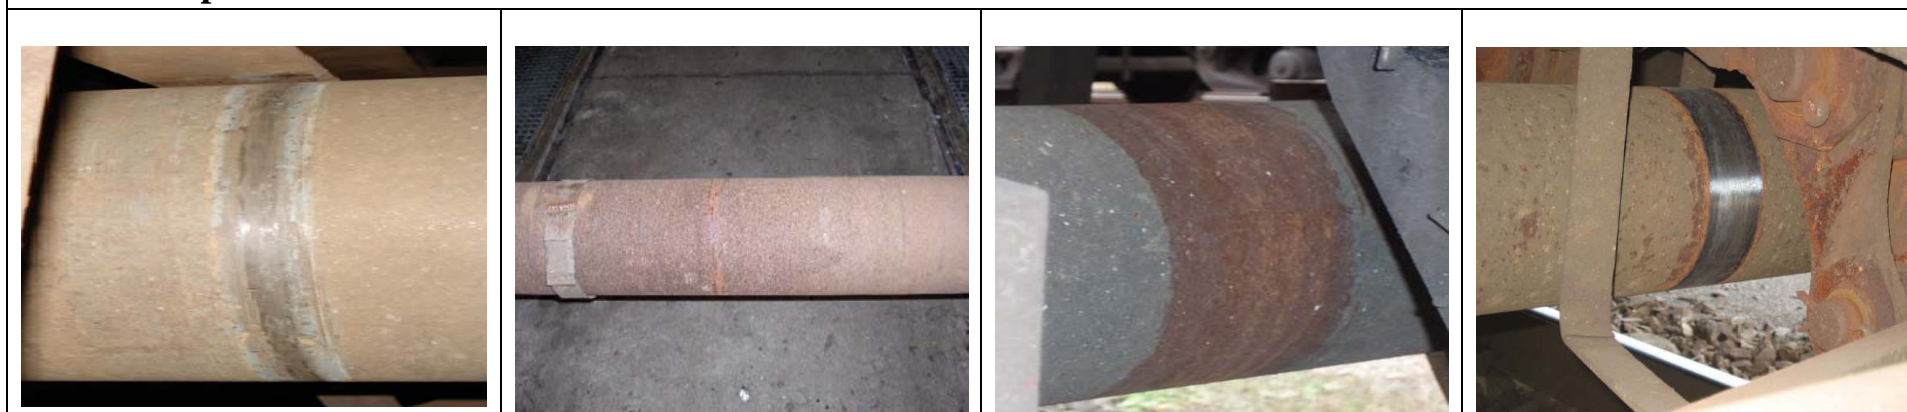
| 42 Mechanical damage – smooth edged circumferential grooves | | Unpainted axles |

| 42 Mechanical damage – smooth edged circumferential grooves | | Unpainted axles |
|---|--|---|
| | Characterised by smooth transitions in the egdes (GCU Annex 9, 1.6.2). Pitting that arises during operation (caused e.g. by brake lever connectors dragging) involves damaged anti-corrosion coating | |

| 42 Mechanical damage – smooth edged circumferential grooves | | Unpainted axles |
|---|--|---|
| | Check on the wagon why this damage could have occurred and repair accordingly | |
| | Remove from service | Case B |
| | if there is damage to the base material > 1mm: (acc. GCU) | Case A |

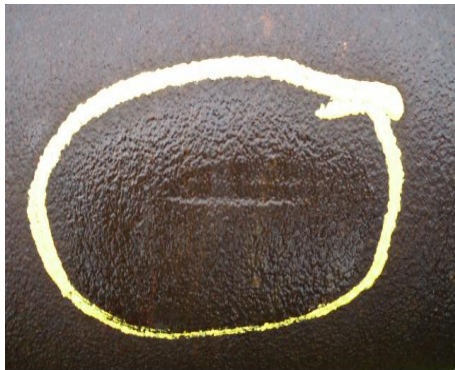
| 43 Mechanical damage – sharp edged notching | | Unpainted axles |

| 43 Mechanical damage – sharp edged notching | | Unpainted axles |
|---|---|---|
| | Sharp edged notches occur locally and are characterised by sharp-edged transitions. | |
| | Mechanical damage to the base material in the form of notching is inadmissible. | |

| 43 Mechanical damage – sharp edged notching | | Unpainted axles |
|---|---|---|
| | Remove from service (according to GCU criteria) | Case A |

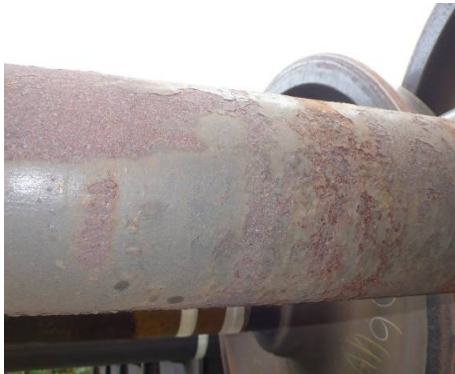
| 45 Surface damage – large and heavily corroded areas | | Unpainted axles |

| 45 Surface damage – large and heavily corroded areas | | Unpainted axles |
|--|---|---|
| | Surface damage to base material in form of large and heavily corroded areas (old corrosion protection) is inadmissible. | |

| 45 Surface damage – large and heavily corroded areas | | Unpainted axles |
|--|---|---|
| | Remove from service | Case B |

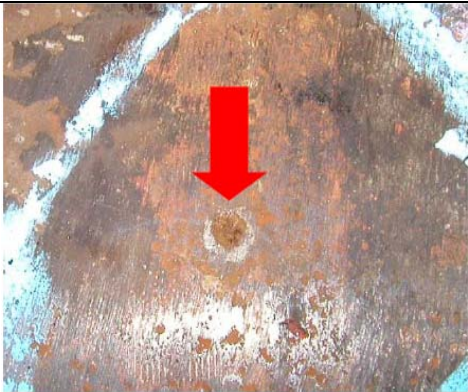
| 46 Surface damage – single, deeply pitted corrosion scars | | Unpainted axles |

| | Surface damage to the base material in the form of marked, local corrosion scars (resulting e.g. from chemical effects) is inadmissible. | |

| | Remove from service | Case B |

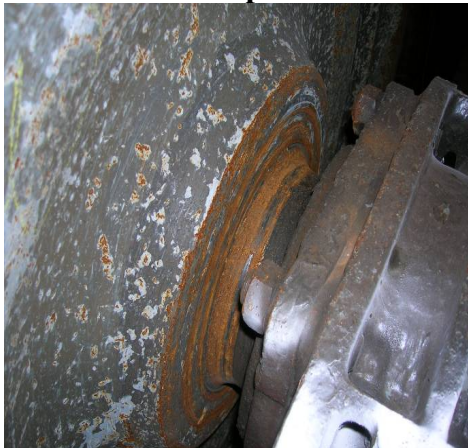
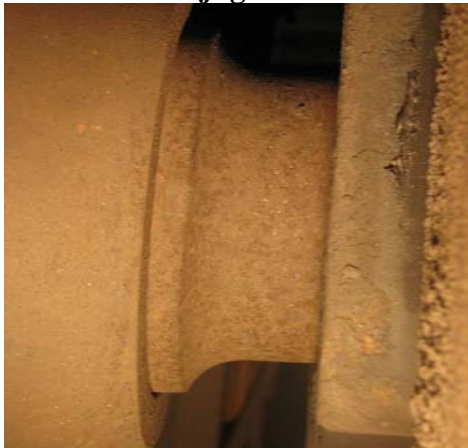
| 50 Abutment area | | All axles |

| 50 Abutment area | | All axles |
|--|---|---|
| | Normally, the abutment area cannot be inspected sufficiently for wheelsets mounted in the wagon | |

| Pictorial representation: | | | |
|--|--|--|--|
| Not acceptable | | Not judgeable | |

| 50 Abutment area | | All axles |
|--|---|---|
| | Take wheelset out | Case A |
| | Leave wheelset in service | |
